OsteoBridge[™] IKA

Knee fusion for failed total knee arthroplasty with recurring infection

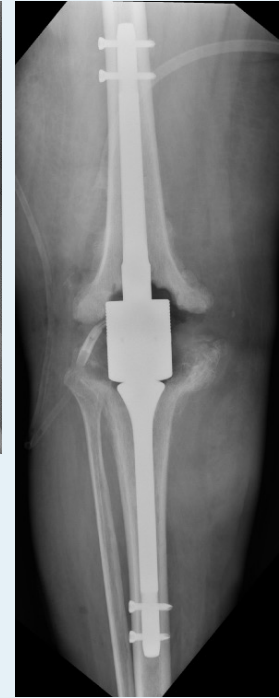
Figure 2: Post-Op fusion with Merete® IKA system

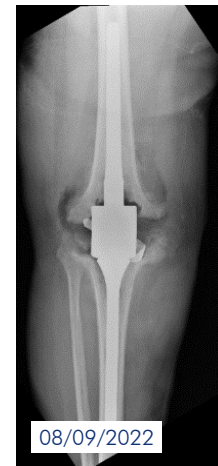
Figure 3: Radiographs of trial between procedures confirming fit

Surgery was planned as removal of spacer, thorough debridement, insertion of a trial Merete® nail and closure. The patient was then transferred to a clean room for insertion of the final Merete® IKA System. A radiograph (Figure 3) was taken between room transfers to confirm proper sizing and position of the nail.

Patient was taken to the operating room with spinal anesthesia in place. Leg draped in supine position with a tourniquet. Approach utilized the previous lateral incision with attention to avoid previous gastrocnemius flap. Patellectomy was performed and the spacer was exposed underneath the extensor mechanism. The cement spacer on the femur was found to be fractured and was removed piecemeal. Tibial spacer removed by drilling multiple holes into the cement and then was fractured with an osteotome. Dowels from the tibia and femur were removed with a Kocher once freed up by a small osteotome. Medullary canals were exposed and power reaming up to a 13 reamer on both femoral and tibial sides. Extensive debridement of necrotic tissue performed and irrigation proceeded with 3 liters of Betadine solution and 3 liters of saline solution. The space was then tediously crafted to allow for placement of a trial Merete® spacer using a 16 nail in the femur and a 12 nail in the tibia and the appropriate joining clamp was placed. Fondaparinux and a sterile lap were placed in the wound which was then loosely closed and wrapped with a compressive dressing and an antimicrobial adhesive drape. X-ray was completed to confirm proper placement of trial nail (Figure 3).

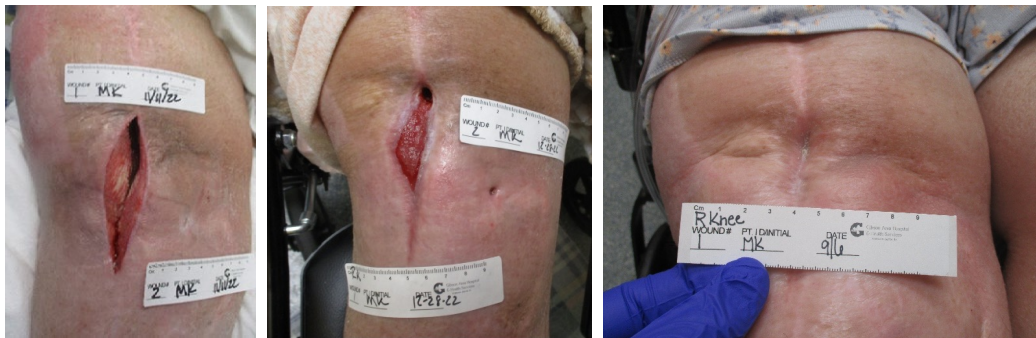
Figure 4: Wound healing progression post debridement and wound VAC placement.

Due to continued draining sinus proximal to the gastrocnemius rotation flap, patient returned to the OR for irrigation and debridement, and wound VAC placement. Wound clinic managed the wound with progression to complete closure (Figure 4).

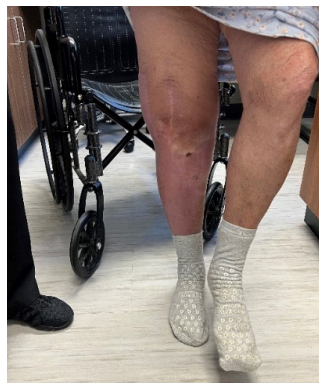
Figure 6: Standing on one leg, full weight bearing

Patient progressed to ambulating pain-free on the fusion nail with a well-healed wound and the inflammatory markers have become normal. She is happy with the outcome (Figure 6, 7).

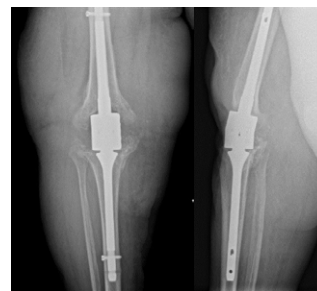
Figure 7: Patient now fully weight bearing, without pain, no draining sinuses, and no shortening after screw removal.
